## Longer lifetime for velocity and concentration sensors

(Source : *Ports & Dredging* nr. 145 from 1995)

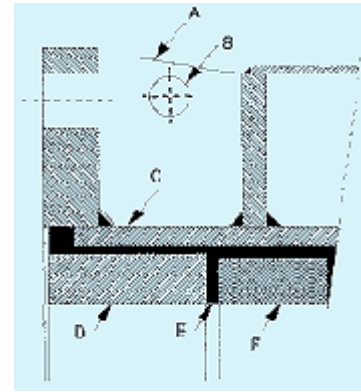
These sources of problems have, after comprehensive research into the matter, led to a number of improvements on the transmitter tubes, so as to stop them being the weakest points in pipes: the liner is made of highly scour resistant, tough aluminium oxide tiles, which are made smaller and thicker than before, to further reduce the chances of breaking (F); the ceramic tiles are embedded in a strong irathane layer, which also fills the seams (E); on both sides the ceramic liner has got a steel capping ring, which bears the brunt of impact erosion (D); the stainless steel inner tube of the velocity meter has been made thicker, to increase stiffness and avoid the breaking of ceramic tiles (C); by making the pipe's wall thicker and extending the knees (with holes (B) to facilitate handling) to rigidly fix the flange and the sensor's housing, stiffness is greatly improved (A).

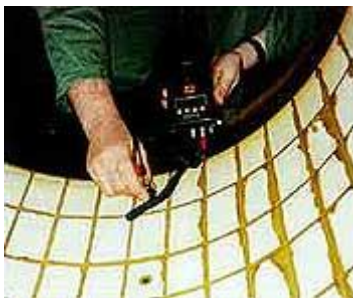
In the Taurus tests, a number of test pipes were fitted in the 850 mm discharge pipe: one was a newly designed velocity meter, with aluminium oxide tiles and the highest quality cast steel capping rings, while other test pipes had liners of cast basalt, irathane and a combination of aluminium oxide embedded in irathane. After dredging approximately 1/2 million m<sup>3</sup> caprock, calcerite, limestone and sand, all liners were worn out, except the aluminium oxide one, which still looked like new even the odd cracked tile was still in place, thanks to perfect glueing. Far over 4 million m<sup>3</sup> solids have passed the liner, but there is still no measurable wear.

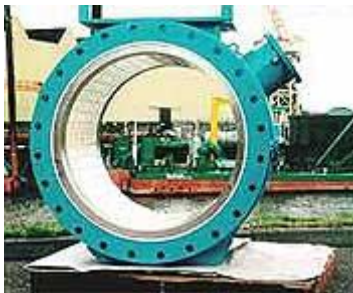
When dredging coarse material, big boulders might hit the pipe's wall and it was deemed useful to know what the aluminium oxide tiles could bear before bursting. A test was developed which could also help in comparing the quality of various parties of tiles. A reference measuring experiment was set up to compare different materials as well as testing the quality of tiles. In the experiment, the tiles were subjected to a dropping object, the weight and height of which could be varied. The results were registered and measured by acceleration meter and suitable software. Maximum strength, fatigue and strength of tiles under impact at the rim were investigated. The experiments clearly proved that being glued in vastly improved the aluminium oxide tiles' impact resistance.
